# **THE VULNERABILITY OF NEW ZEALAND LIFELINES INFRASTRUCTURE TO ASHFALL**

**A thesis submitted in partial fulfilment of the requirements  
for the Degree of Doctor of Philosophy  
in Hazard and Disaster Management  
in the University of Canterbury**

**Scott Trevor Barnard  
2009  
Department of Geological Sciences**

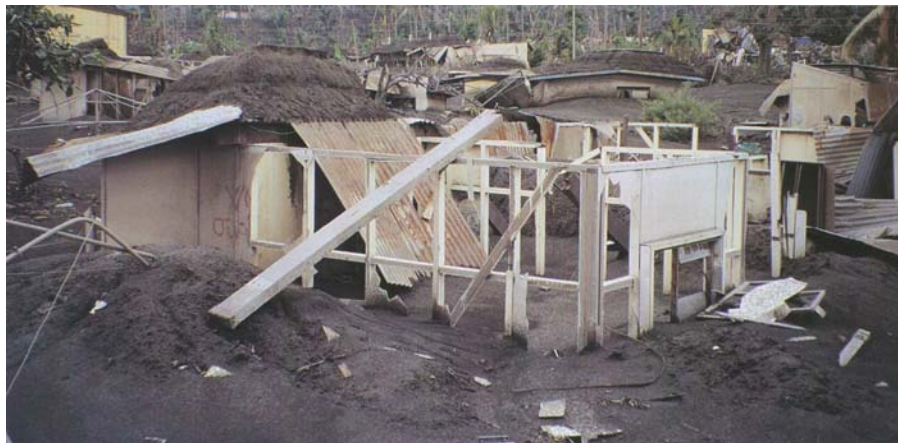
*Figure 1.2: Collapsed police barracks in Rabaul, 1994, after being covered by >600 mm of ash (Blong & McKee, 1995).*

Ash is heavy, and it can be produced and deposited in large volumes. The weight of thick deposits of ash may exceed design loads of structures. Furthermore it may absorb up to 50% of its own volume in water, increasing its weight significantly. This can lead to building and/or roof collapse, something that has featured in many historical eruptions, e.g. Tarawera 1886 (Keam, 1988), Pinatubo 1991 (Casadevall et al., 1996), Rabaul 1994 (Blong & McKee, 1995). Roof collapse may occur with as little as ~15 cm of ash, damage may occur with even less. Figure 1.2 illustrates roof collapse in Rabaul, 1994.

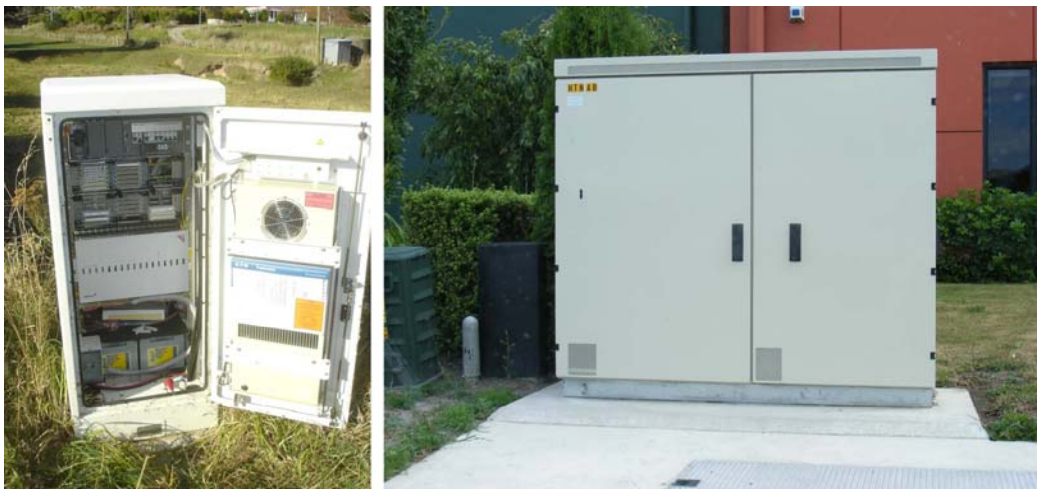
*Figure 2.2: Rural exchange 24RU cabinet (left) and new roadside cabinet (right).*

Rural exchanges and roadside cabinets have a similar construction – essentially a steel or 2.5 mm thick aluminium box mounted on a steel plinth. These are unlikely to be damaged by tephra loading due to their sturdy construction, unless indirectly damaged by other objects such as falling trees collapsing under ash loading (figure 2.2).

Rural exchanges vary depending on the size of the communities they serve, but are typically housed in small cabinets, such as the 24RU cabinet in figure 2.2. Cooling is effected by two different means depending on the age of the cabinet. Older cabinets use a small fan, which draws in outside air to the cabinet through one layer of filter media, newer cabinets use a separate internal and external fan with a heat exchanger in between the two. Unfortunately neither cooling system was available for testing during the course of this research. However testing of filter media during larger scale air-conditioner testing (chapter 3) indicates that the use of fresh air fans and filters is likely to result in both initial ingress of ash to the exchange and eventual blockage of the filter. This may result in bridged connections and component failure due to conductive ash causing shorts, then overheating as the filter becomes blocked. Newer sealed units should not be affected by ash ingress, but the exterior part of the heat exchange may become blocked with ash, depending on ash grainsize and airspeed. Once temperatures exceed 47°C a high temperature alarm triggers, automatic shutdown of equipment occurs at 54°C, and requires a manual power reset.

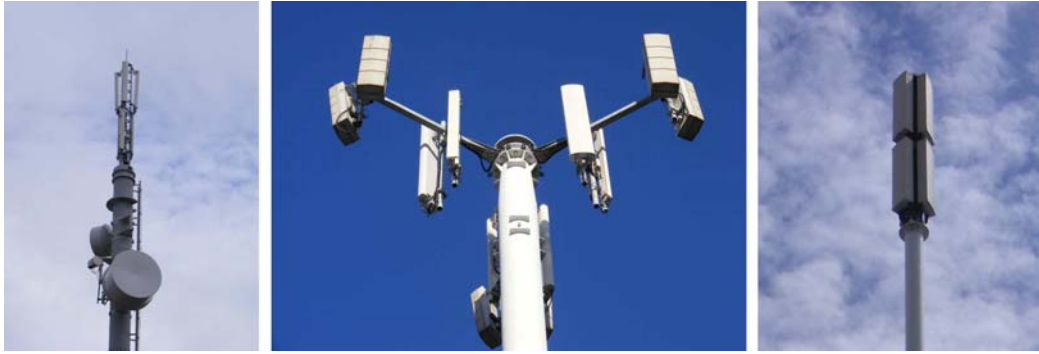
*Figure 2.3: Left to right, microwave transmitter dishes and single cell site plus long wavelength antenna; Single cell site tower; 2G and 3G Telecom cell tower.*

Many of New Zealand's cell phone exchanges are housed in converted shipping containers. These are unlikely to be affected by ash loading due to their steel construction. Other purpose built cabinets are also robustly constructed of galvanized steel, and are again unlikely to be affected in this way, unless tephra loading extreme enough to destroy almost all other nearby buildings occurs. The lack of any significant horizontal surface area on cell towers and microwave transmission towers mean that tephra loading is unlikely to be an issue in this regard (figure 2.3).

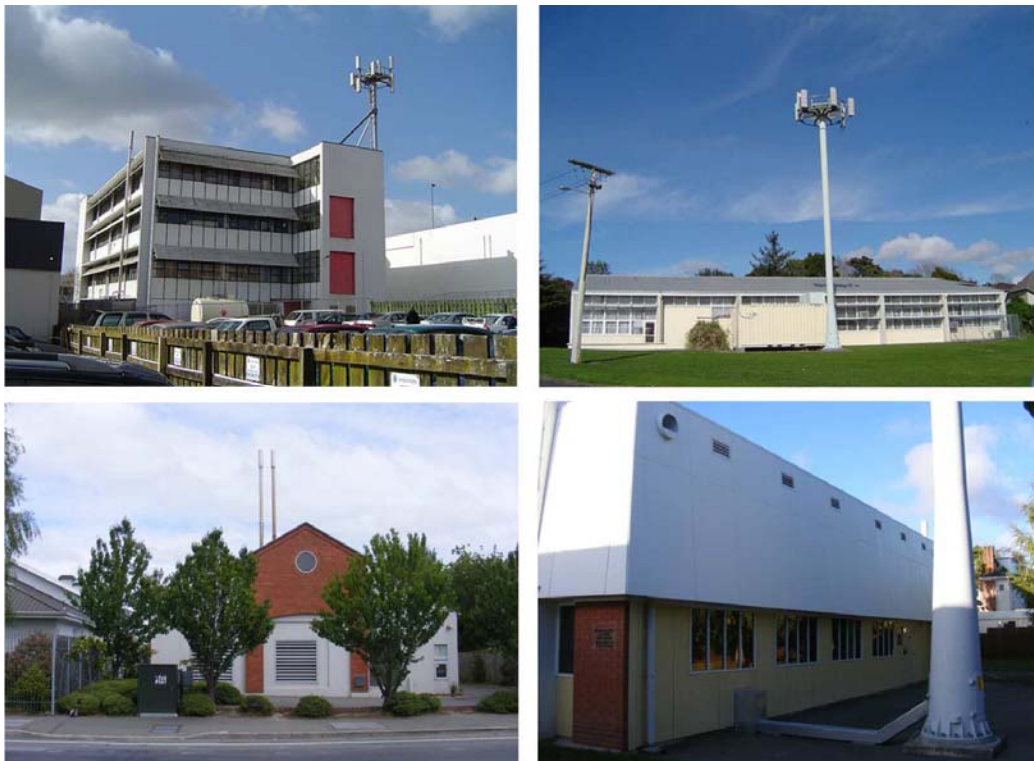
*Figure 2.4: New Zealand urban telephone exchange buildings. Top 2 photos © James Pole*

While not as strong as the aluminium or steel containers and cabinets that house cell and small rural exchanges, urban exchanges are usually housed in robust buildings. Building type varies immensely; there is no standard type of exchange building. Construction types include weatherboard, brick or concrete purpose-built exchange buildings and even space in multi-storey office-blocks (figure 2.4).

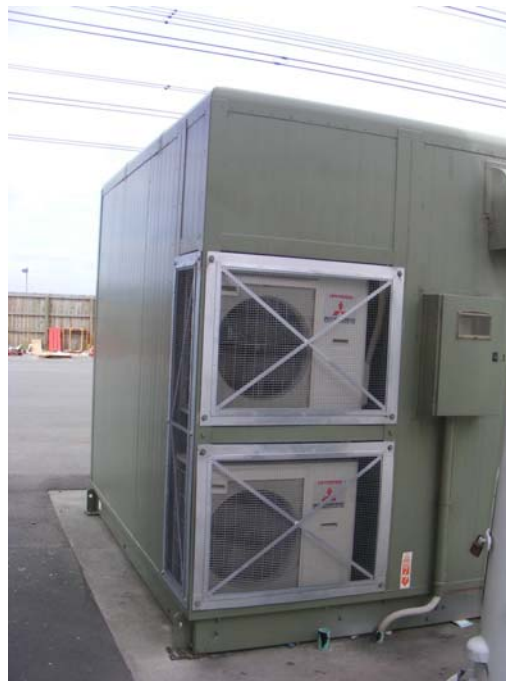
*Figure 2.6: Cell phone exchange air conditioners.*

Cell sites typically have two split system air-conditioning units present, one of which acts as a backup (figure 2.6). Each unit has a cooling capacity of about 6KW, which equals the amount of internal heat produced within the exchange. Normal operating temperatures are below 25°C. Once internal temperatures exceed this amount the second unit starts up (D. Johns, pers. comm., 2009). This means that under normal circumstances the available cooling capacity is 12KW, or 200% of internal heat generation. Until the efficiency of both units drops below 50%, the two air conditioners running simultaneously should be able to maintain production of sufficient cool air to enable the exchange to keep running.

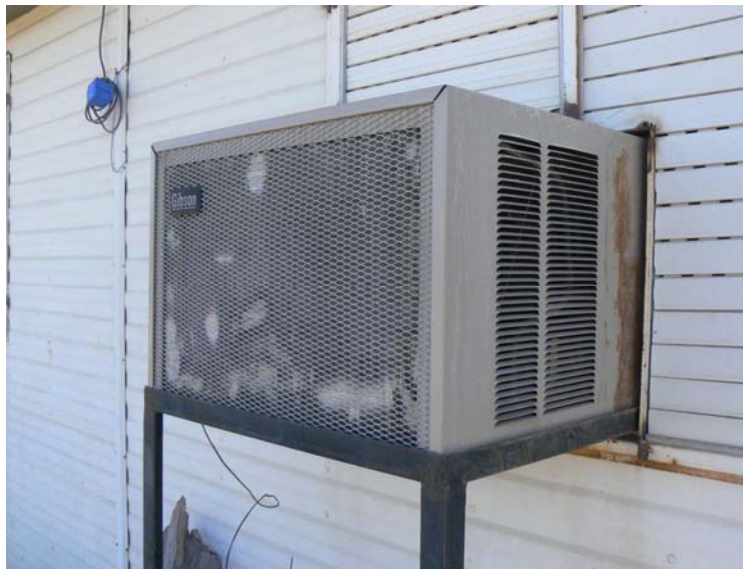
*Figure 3.1 Air conditioning unit used in Trevelin, Chile, subjected to 60 mm of ash with no adverse impacts.*

The eruptions of Chaiten Volcano in Chile (2008-2009) have recently given an example of more than a few millimetres of ashfall impacting developed areas. From the 2<sup>nd</sup> to the 6<sup>th</sup> of May 2008 approximately 60 mm of very fine ash was deposited on a cable television relay building 100km from Chaiten, in the town of Trevelin. Local technical staff reported that there was no impact on their air conditioner performance; it kept functioning normally, and had no protection aside from a foam rubber pad placed over the top to shelter it. No additional maintenance was required afterwards (Wilson, T pers. comm., 2009). The unit type was a through-wall design, which is an older design, and though still used is not as common in New Zealand as conventional split system units (figure 3.1).

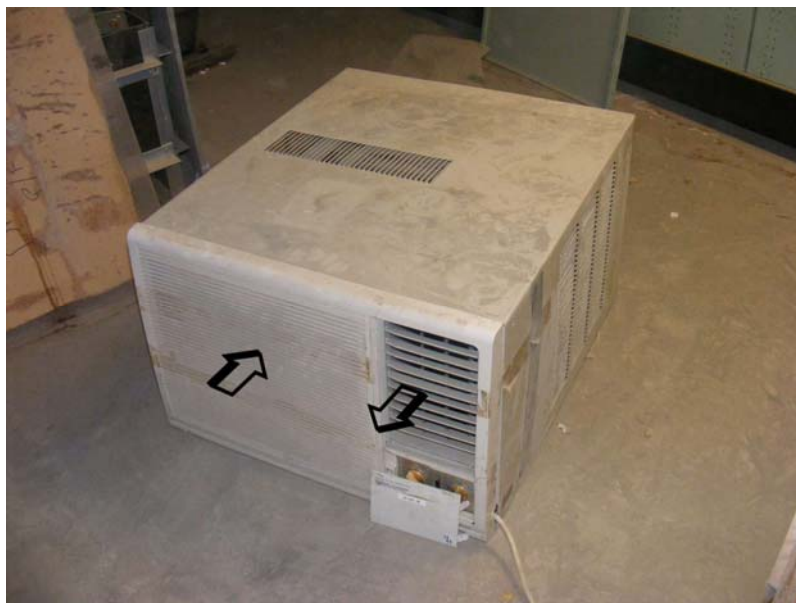
*Figure 3.4 Mitsubishi MWH 17KV interior side. Arrows indicate air direction*

No outside air is brought inside with heat exchange units, this includes through wall units. The MWH 17KV is divided down the centre, with the only connections between the two halves being the pipes through which the refrigerant moves to enable the heat exchange, and a prop shaft which connects and turns both fans (the same motor thus powering both fans). Interior air is drawn into the unit through the radiator (evaporator when cooling) and blown out again in the same manner, cooling the interior of the building (figures 3.3 & 3.4).

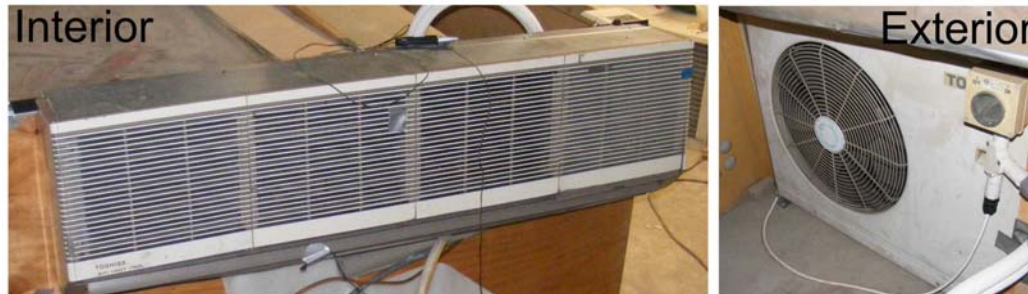
*Figure 3.5: Internal and external sections of Toshiba RAV-200 split system pre testing*

The second unit tested was a Toshiba RAV-200KH split system unit, one of Toshiba's light commercial range of air conditioners (figure 3.5). This unit was taken from an urban telephone exchange in Christchurch as part of a general maintenance program. Units are retired after a few years even when working well; this unit was in perfect working order. It has a cooling capacity of 5.8KW, slightly higher than the first unit tested. Being a split system this air conditioner consists of two sections; an outside unit and an inside unit. These are connected by pipes carrying refrigerant. During testing the inside unit was not subjected to any ash, and ran as it would under normal circumstances, sucking air from the room through an evaporator with a fan, and blowing the cooled air out again into the room. The outside unit drew air through the condenser via a large fan, which pushed air out of the reverse side of the unit. This type of unit is found worldwide in a variety of applications. It is also typical of those used by Telecom in both exchange buildings and cell tower exchanges all over New Zealand. Fin spacing in the condenser is 2 mm. For the purposes of testing the thermostat was repositioned on the outside of the air-conditioner where it would remain at room temperature, ensuring the unit continued to operate at maximum capacity for the duration of the testing.

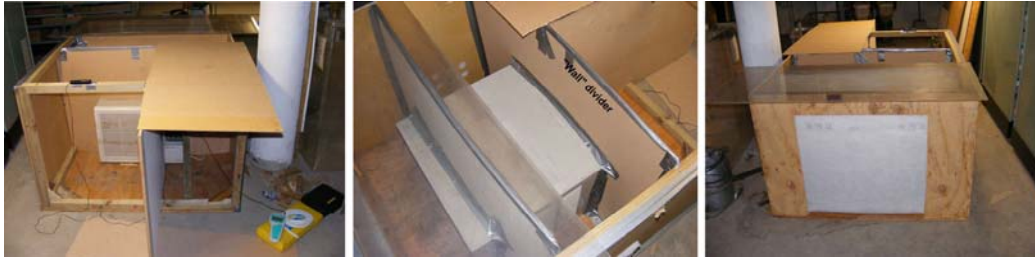
*Figure 3.6: Left: Interior air side of MWH 17KV air-conditioner with intake and outlet separated to monitor temperature. Centre: looking down on the unit, ash was introduced in this central area. Right: the filter covering the exit for the exterior air*

Air moving through the exterior section of the system would be carrying any ash which had not lodged within the unit. To prevent large quantities of this ash entering the testing area and eventually being redrawn into the air-conditioner, a filter was used instead of an end wall in the test box. This also allowed air to freely leave the test box. This was necessary as the intake and output areas were separated, a solid box with a separation between the air intakes and output side would leave the air with nowhere to go, resulting in the creation of backpressure, which would in turn prevent air being drawn into the unit in the normal manner. Figure 3.6 illustrates the setup of this experiment.

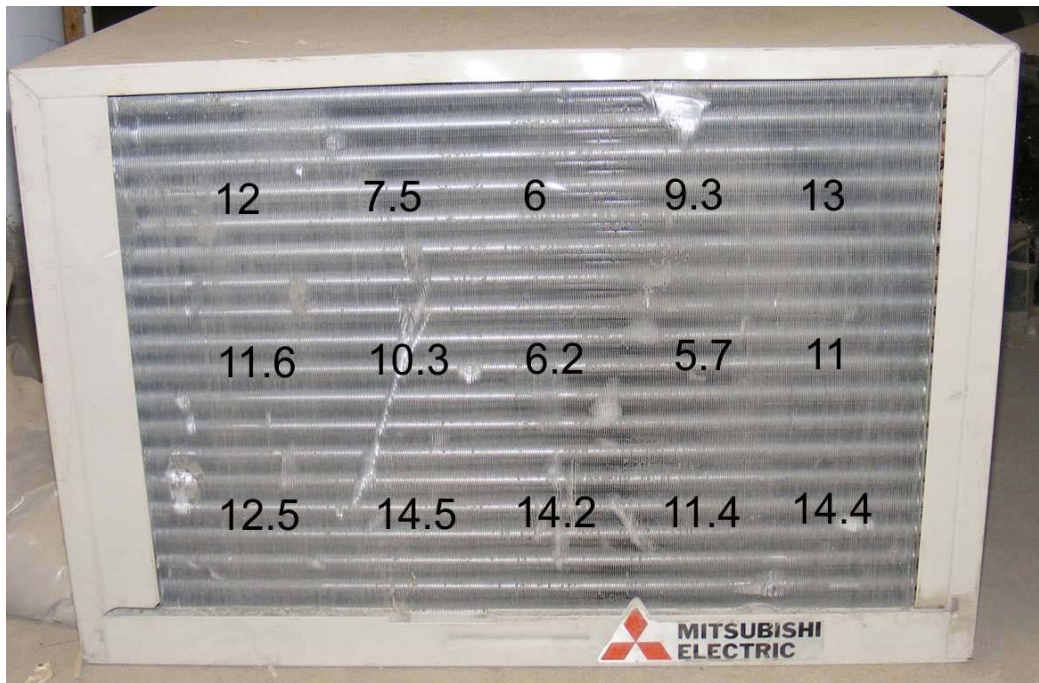
*Figure 3.7: Airspeed (km/h) outside the exterior condenser prior to testing*

The filter used was EU3 media, as used by Telecom in the fresh air intakes on urban exchanges. This type of filter is designed to remove coarse particulate matter, but below 100 microns performance drops off; 80% of particles at 10 microns will be caught, 45% of particles at 1 micron. This would not only stop (some of) the ash from escaping into the room, but give an indication of the effectiveness of such filters in an ashfall. Regular cleaning of this filter was undertaken to prevent blockages from slowing output air and affecting the performance of the air-conditioning unit. The top of this part of the unit was covered in a Perspex sheet to prevent ash escape but leave the interior visible. The input area of the unit was uncovered, to allow ash to land on the unit. The divider between it and the interior part was positioned as a wall or window would be under ordinary installation of this type of air-conditioner. The area of this section measured 430 mm x 1160 mm, giving a surface area of  $0.499\text{m}^2$ . This equates to the approximate area affected by the airflow created by the unit. 100 ml of ash by volume therefore equated to a thickness of ash of  $\sim 2$  mm. Similar divisions were employed on the interior (evaporator) side, without the need for filtration. All dividers were sealed to prevent ash or air of a different temperature affecting results. Exterior air (ambient air) was continuously monitored with a room thermometer, the performance of the air-conditioning unit was continuously monitored with a cyberscan pH/temperature meter positioned 5 cm in front of the interior air outlet. Airspeed was monitored outside the condenser pre testing, with 15 readings taken in a grid pattern in front of the unit. These values average out at 10.6 km/h.

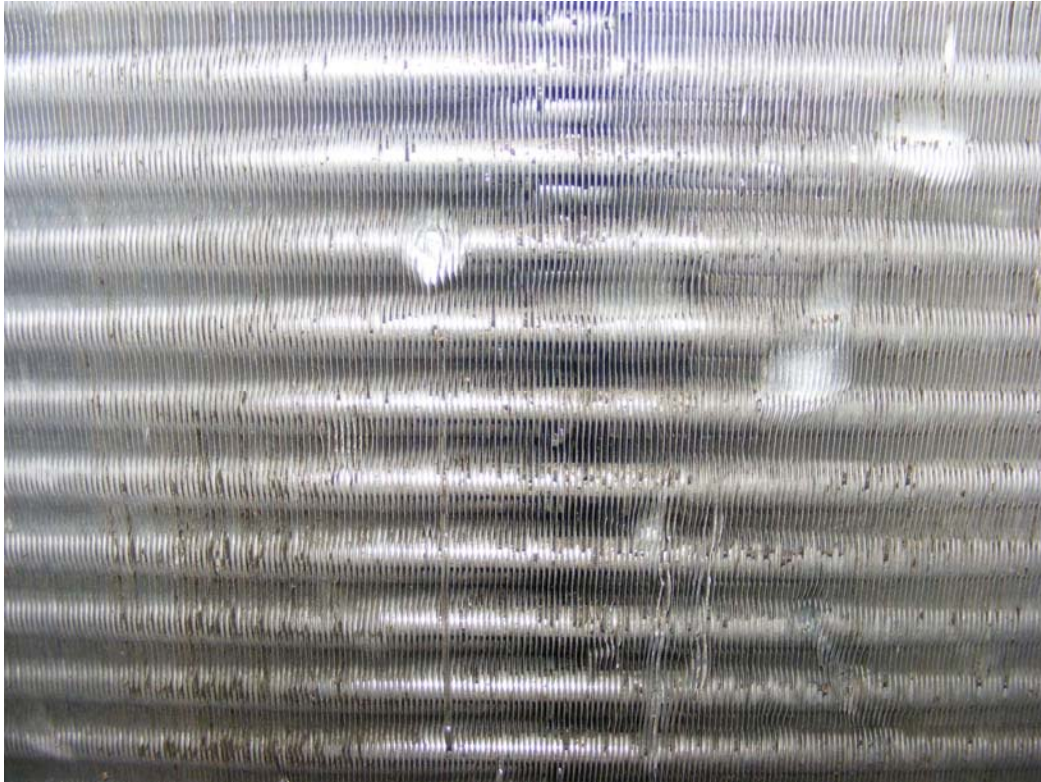
*Figure 3.12: Condenser after 5 mm of wet ash. Note small amounts of ash adherence*

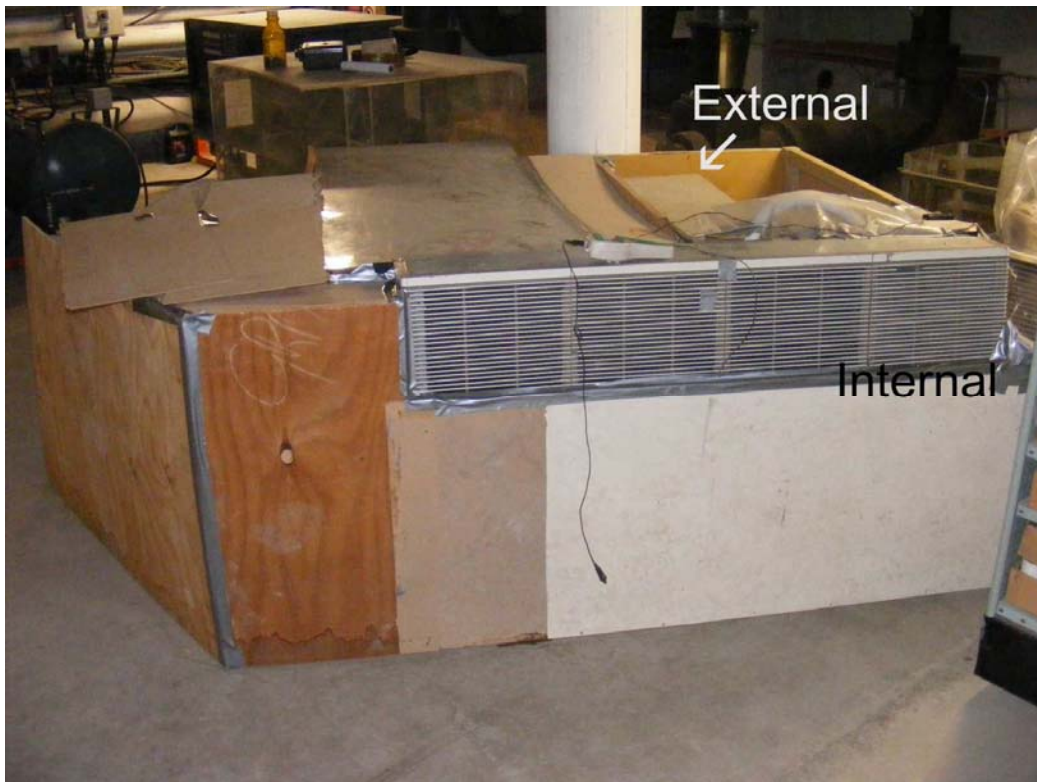
*Figure 3.15 Toshiba unit test setup. Ash was introduced behind the external unit (to the right in this photo). Ash and air moved through the unit from the right of this photograph to the left. The internal part of the system drew air in through the intake facing the camera, and out to the left after mixing with air from the external part, thereby maintaining constant ambient temperature.*

The setup for the testing of the Toshiba unit followed the same principles as those used in the testing of the Mitsubishi air conditioner. A large box with a filter in the end wall was constructed to house the exterior part of the unit. A divider separated the back and front parts of the unit, to prevent the air that was being drawn into and blown out of the unit from mixing. This could result in temperature fluctuations. The top of the intake area was left open so that ashfall could be simulated, the outlet on the exterior side was lidded to keep the ash from entering the room where it would be entrained in the inside part of the unit (figure 3.15).

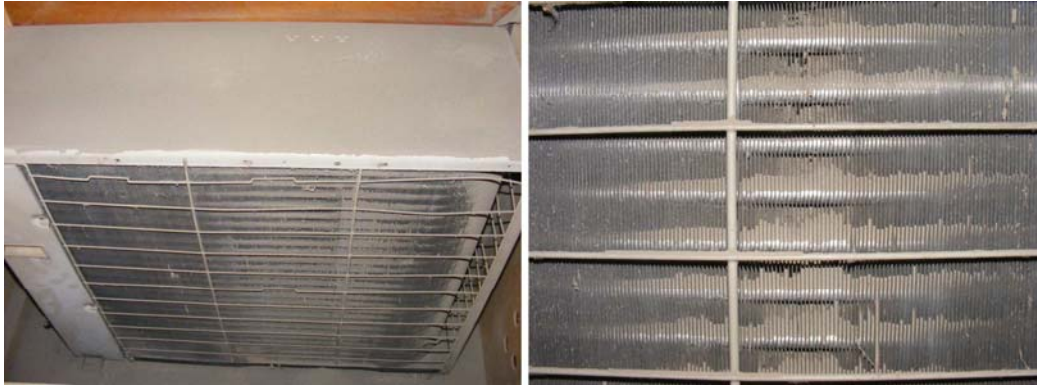
*Figure 3.18: Exterior unit condenser after 9 mm of ashfall. Note ash accumulating on horizontal coils*

Photographs taken at this time show ash lodged within the unit, resting between condenser fins, supported by the horizontal coils (figure 3.18). It is thought that the ash caused an insulating effect on the condenser, preventing heat from escaping. This is because although temperatures had risen and some ash was present within the condenser, there was not enough to cause any significant blockage to airflow.

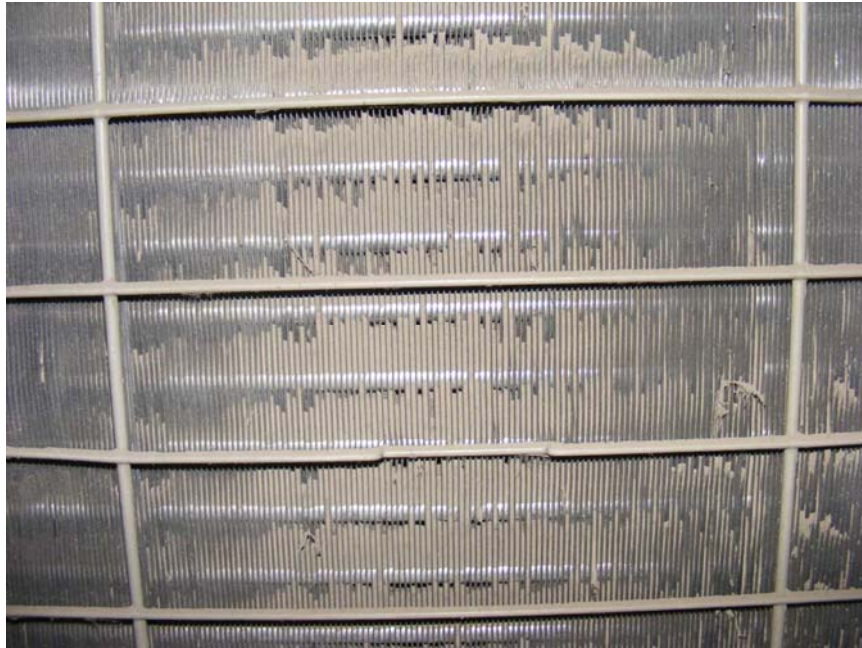
*Figure 3.19: Condenser accumulating ash after 18 mm of ashfall*

millimetre of ashfall, the total amount now 19 mm. Figure 3.19 illustrates ash lodging in the condenser after 18 mm of ash

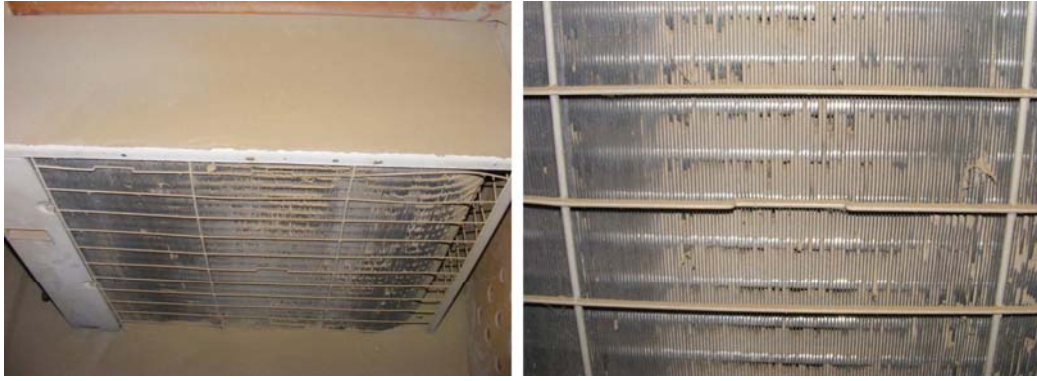
*Figure 3.20: Condenser after 51 mm of ash*

Testing the following day again began with a lower temperature output, of  $12.2^{\circ}\text{C}$ . Internal components within the unit – such as the compressor, had cooled overnight, and had not yet started to overheat, despite the unit being given 60 minutes to run prior to testing. By this time visibly less ash was being drawn into the condenser as blockages began to affect the airflow. In some areas it could be seen being blown back out of the condenser. Once again temperature began to rise as ash was added. By the time the increase in ashfall rate occurred after 660 minutes of testing, temperatures were once again up to almost  $13^{\circ}\text{C}$ . These slowly rose as more and more ash caused blockages in the condenser to increase. Temperatures remained over  $13^{\circ}\text{C}$  but under  $14^{\circ}\text{C}$  until the end of testing for the day, at 820 minutes and over 51 mm of ashfall (figure 3.20). By now the rate of simulated ashfall was at 15 mm per hour.

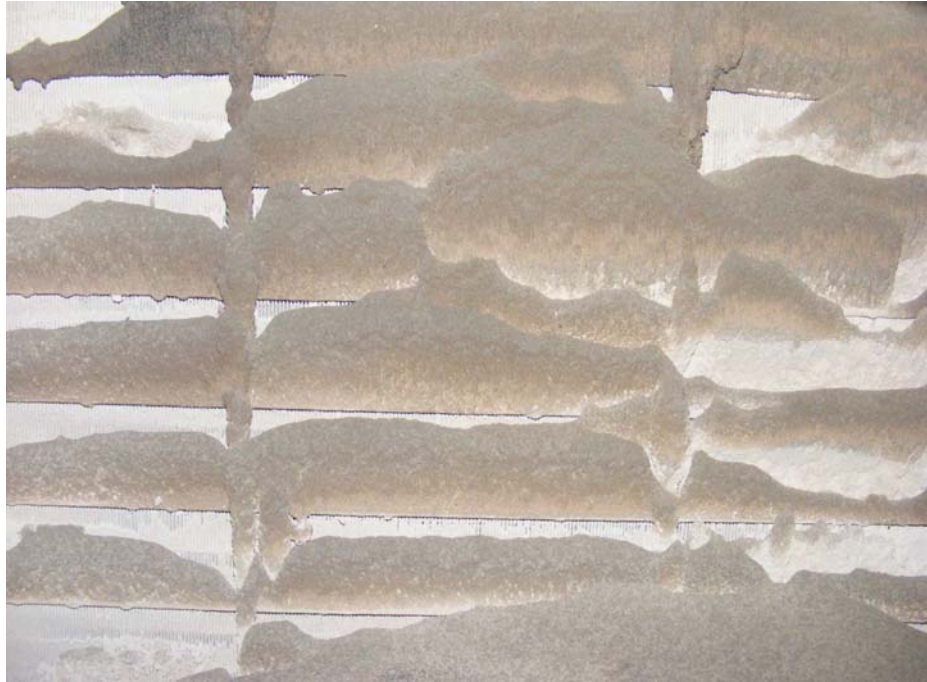
*Figure 3.25: Blister-like accumulation of ash on the external grill of the condenser after ~85 mm of ashfall. Note there are also substantial blockages internally, between condenser fins.*

The pattern of shutdowns for 2 to 6 minutes every 15 to 30 minutes continued until the end of ash addition at 95 mm. Figures 3.25 and 3.26 illustrate blister like accumulations of ash blocking the condenser after 85 mm of ashfall. The unit was run one more time (without the addition of ash) on the following day, having had the chance to cool down overnight. After being left for 4 hours it was monitored for one hour to ascertain whether there had been any change in performance due to being run without ash in the atmosphere. Results are plotted in figure 3.27.

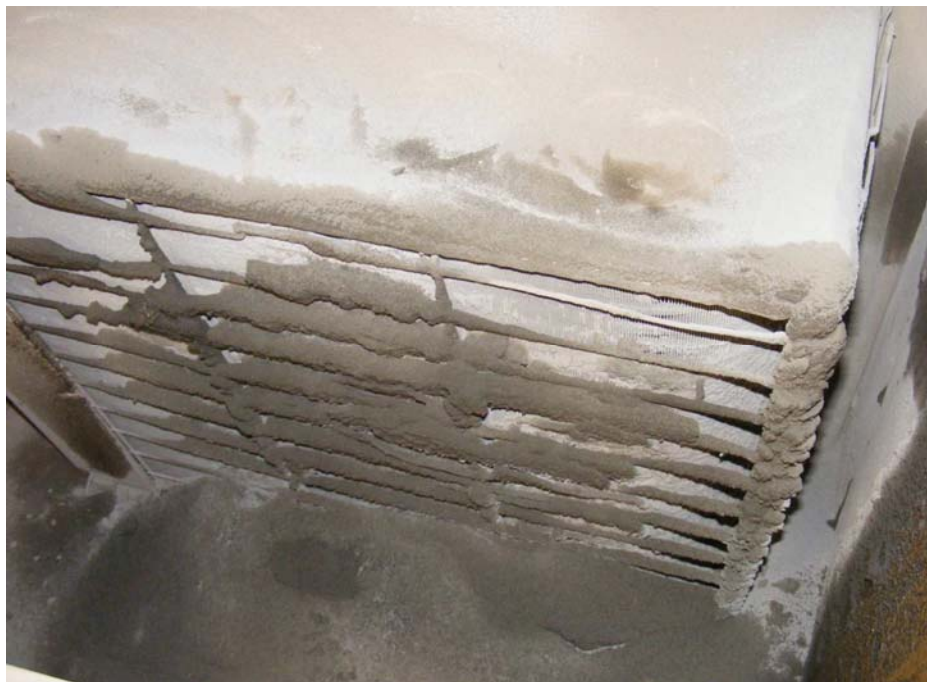
*Figure 3.26: Accumulation of ash on the condenser after ~85 mm of ashfall.*

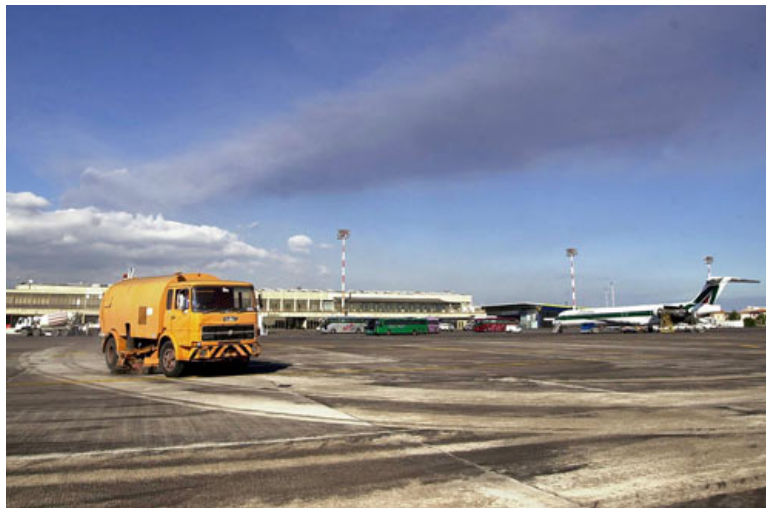
*Figure 4.4: Clean up at Fontanarossa airport*

Runway and apron clean-up was performed by vacuum/sweeper trucks, some of which were street sweepers leased from the local council (ANAS). The trucks would sweep up and down the runway longitudinally. The entire 150,000 m<sup>2</sup> runway area would take 30 hours for a single truck to clean approximately 1 mm of ash from the surface, though this was usually sped up by 2-4 trucks working at once. Not all areas always required cleaning; sweeping would usually take between 2 and 8 hours depending on the amount of ash present on the runway. Water tankers were used to remove residual ash, washing ash to the grassed areas on the sides of the runway. These operated by driving across the runway rather than along it, and used high pressure water. The green areas (safety strips) were wetted, then “ploughed” with a pulvimixer to entrain ash in to the soil, followed by rolling the earth to assist in preventing remobilisation of ash. Using a pulvimixer and roller, 1000m<sup>2</sup> took about one hour to cover. Joints between slabs on the runway and taxiways were also cleaned, using a small vacuum (SAC, 2003). Since the 2002 eruption the airport has purchased an additional street sweeper and water tanker to help in future ashfall cleanups (Guarrera, G., pers. comm., 2005).

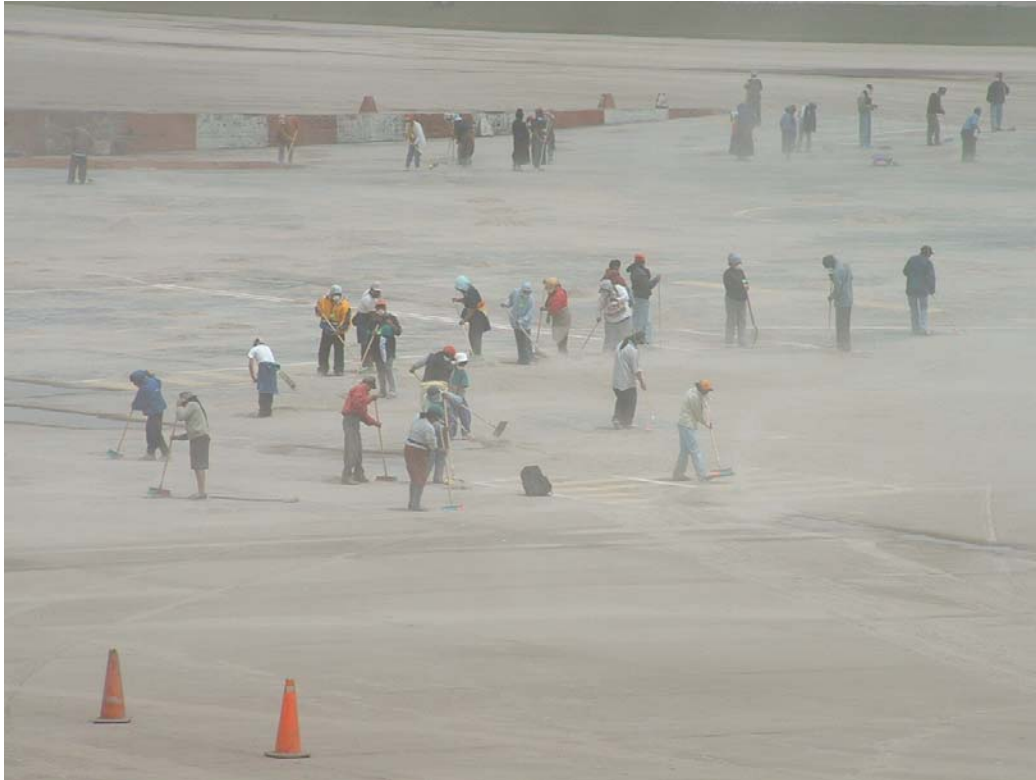
*Figure 4.5: Manual runway cleanup at Mariscal Sucre Airport after the 2002 Reventador eruption. Photo courtesy of Mariscal Sucre Airport.*

Cleaning the 285,000 m<sup>2</sup> of runways and taxiways/aprons was the most time-consuming task related to the ashfall. In each eruptive case the runway cleanup was performed by 500 labourers with brooms, in the absence of available machinery (figure 4.5). One sweeper truck was owned by the airport, however this was found to be ineffective in removing ash.

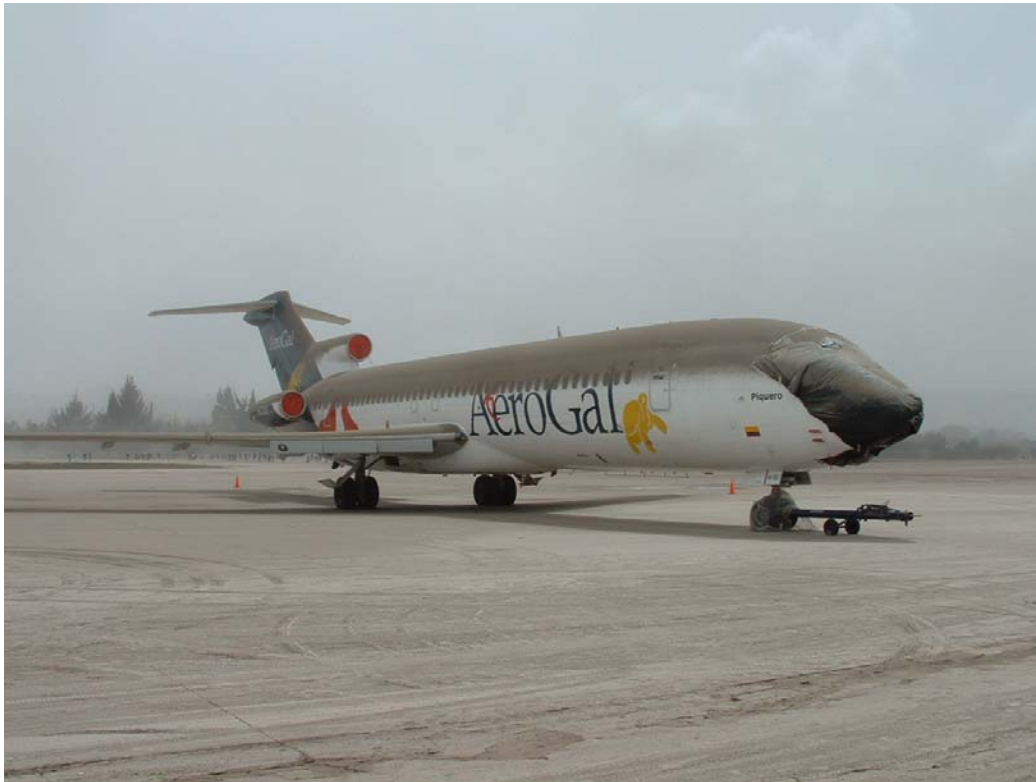
*Figure 4.6: Aerogal Boeing 727 covered in ash from the Reventador 2002 eruption. Note the covered windscreen and nosecone, front wheel assembly and engine intakes. Photo courtesy of Mariscal Sucre Airport.*

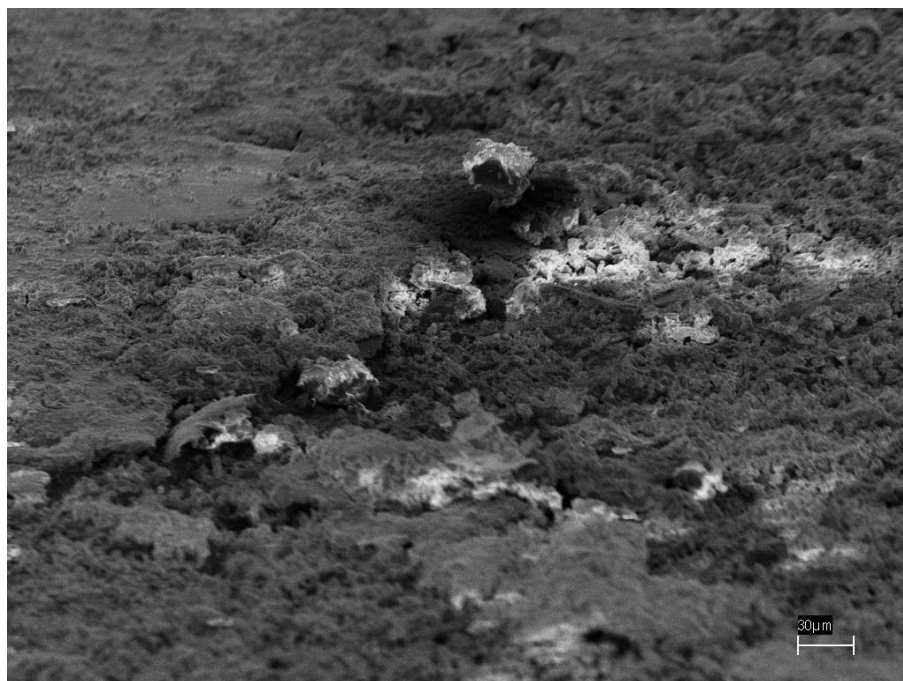
*Figure 4.10: SEM micrograph of 7075-T6 aluminium after being exposed to a leachate of pH 2.5 for 24 hours.*

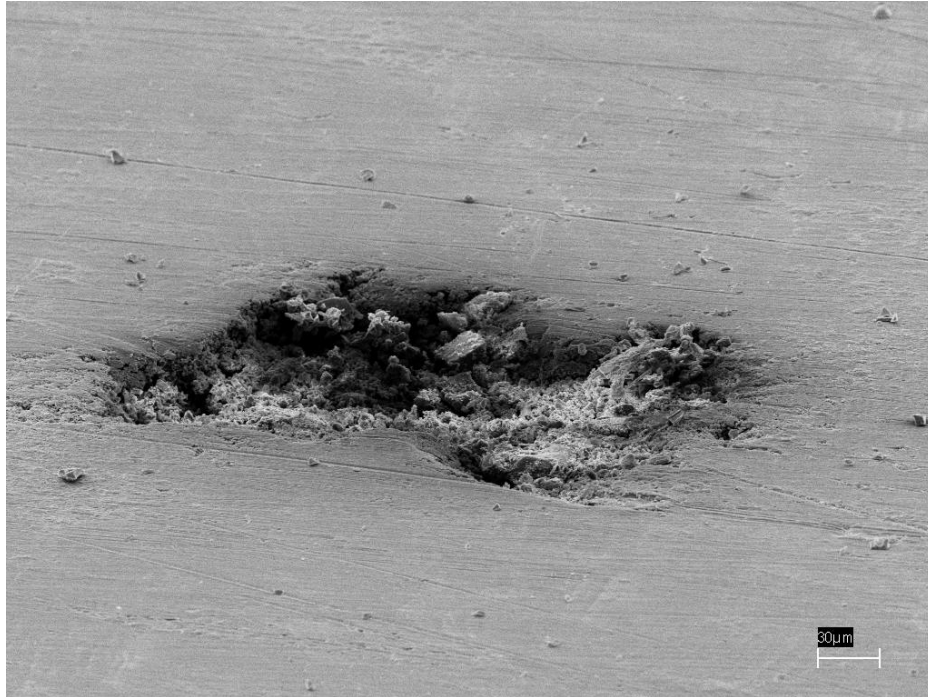
*Figure 4.12: SEM micrograph of clad 2024-T3 aluminium after being exposed to a leachate of pH 2.5 for 24 hours*

As well as surface oxidation, all bare surfaces were found to be subject to pitting. Clad surfaces suffered from deeper pitting than the unclad alloys, due to the preferential electrochemical dissolution of the anodic pure aluminium cladding over the cathodic alloy. In most instances pit depth on clad alloys was 10 – 50  $\mu\text{m}$ , whereas maximum pit depth on unclad alloys appeared to be  $\sim 30 \mu\text{m}$  (figures 4.8-4.12). While pitting on clad surfaces appeared to be deeper than on alloy surfaces, the total surface area affected by pitting was slightly higher on the 7075 alloy than the 2024 alloy. The pure aluminium cladding had a marginally smaller pitted surface area despite the deeper pits.

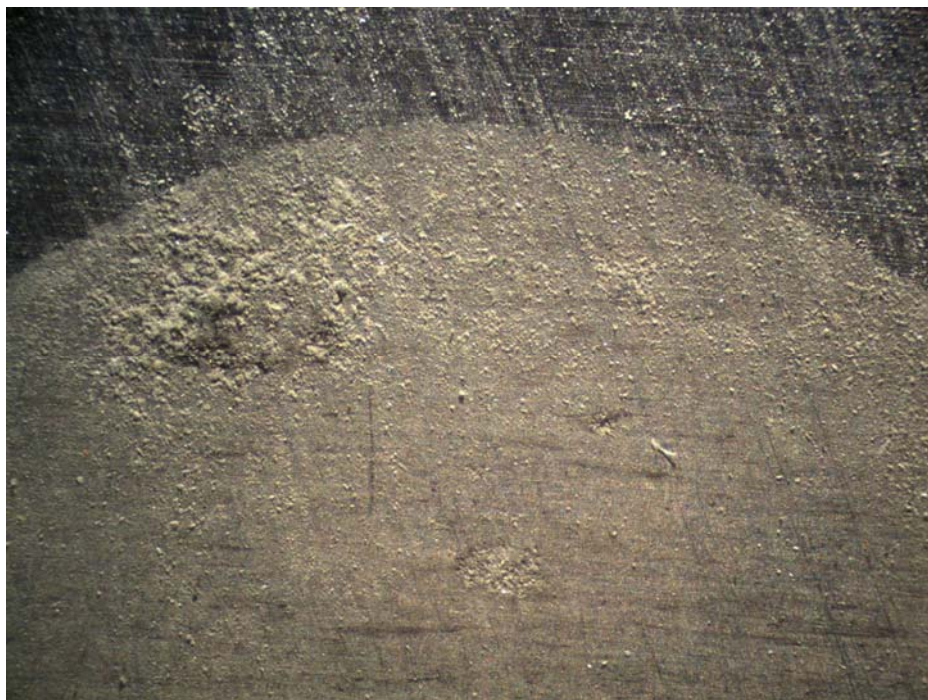
*Figure 4.13: Optical Microscope view of 2024-T3 aluminium after being exposed to a leachate of pH 2.5 for 24 hours. The oxidised surface (lower  $\frac{3}{4}$  of image) clearly stands out against the untested surface. Note pitting. Field of view is 8 mm.*

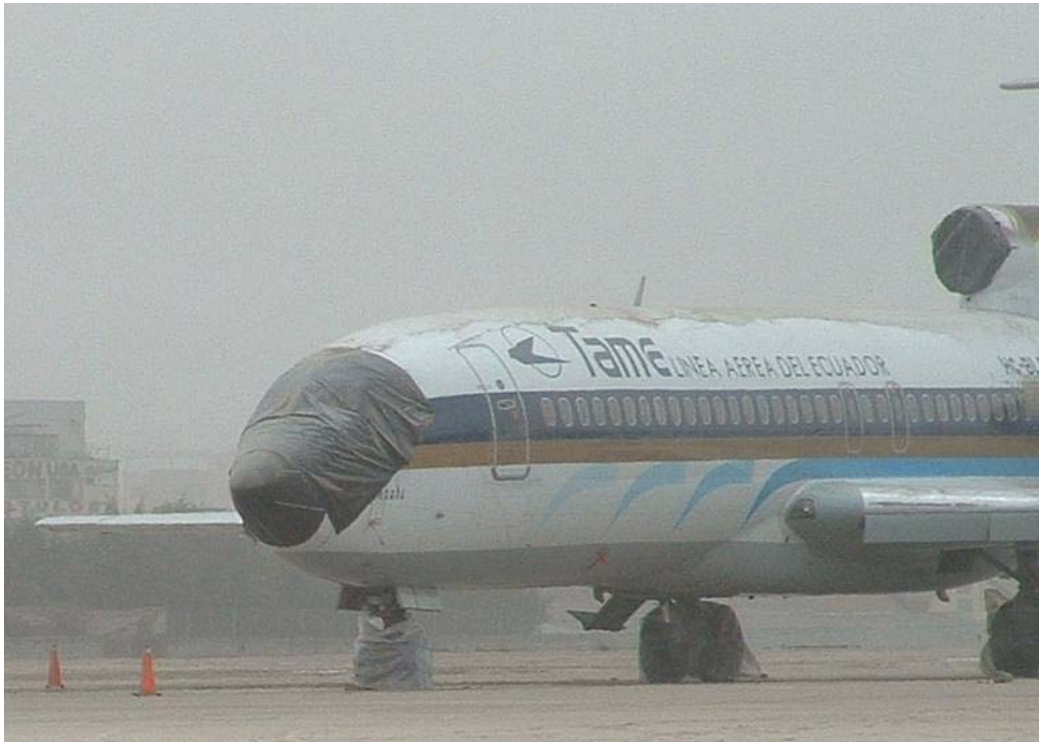
*Figure 4.15: TAME airlines Boeing 727-134 with improvised covers on windscreen, wheel assemblies and engine intakes*

The potential for abrasion while cleaning ash off aircraft surfaces exists, despite negligible abrasion occurring during testing. Different ash types may give different results. The ash used in testing was a fine grained dacite, its high silica content and angular grain shape made this a very abrasive ash. However volcanic ash could potentially be more abrasive than this, and give less benign results. This could occur with a more silicic rhyolitic ash, or even a glassy ash with sharp angular grains. Extreme care should therefore be taken when removing ash from aircraft skins. Abrasion to windshields and windows was not tested, as experience after the Pinatubo eruption suggests these can easily be scratched if rubbed when removing ash (Casadevall, 1992). Ideally windshields should be covered in the event of an aircraft being parked outside during an ashfall (figure 4.15).

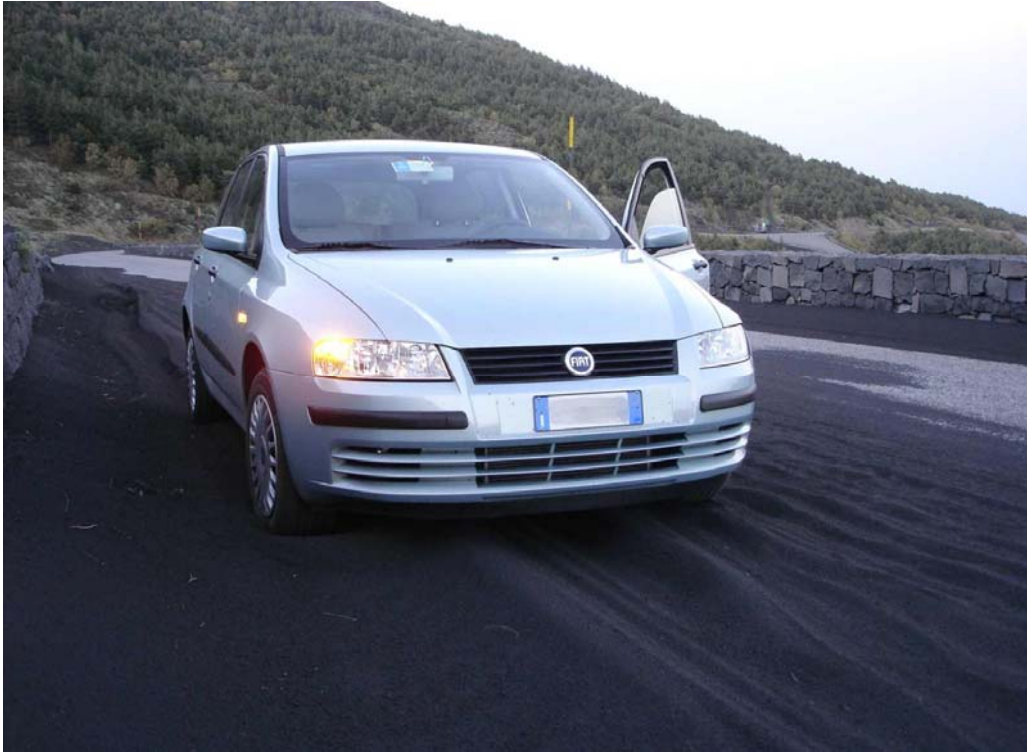
*Figure 5.1: Fiat Stilo during testing on unconsolidated ash near Sapienza, Mt Etna*

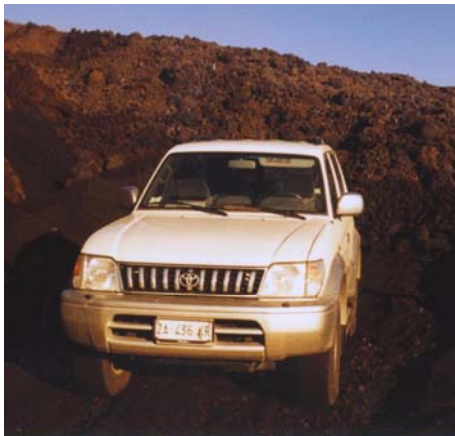
*Figure 5.2: INGV Toyota Prado on ash Covered track on Mount Etna*

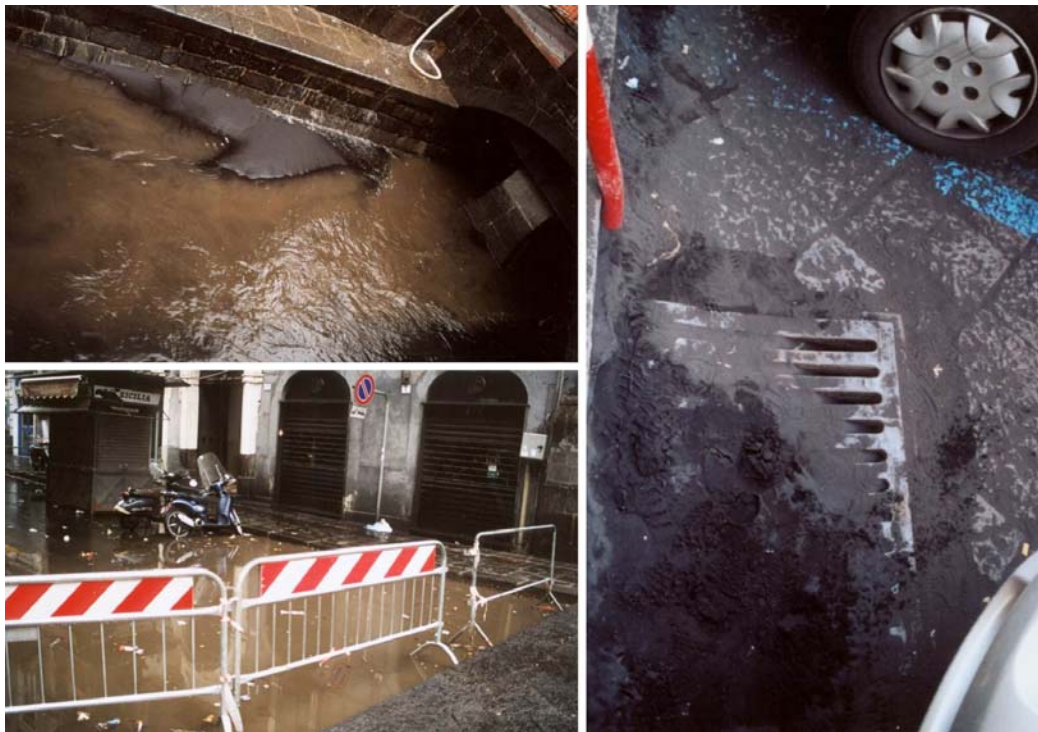
*Figure 6.1: Ash in Catania during the 2002 Etna eruption. Clockwise from top left, sedimentation in open drain, blocked stormwater drain, localised flooding due to ash in drains.*

The 2002 eruption of Mt Etna, Sicily resulted in small amounts of ash being deposited on the city of Catania several times over a 3 month period (Barnard, 2004). Combined with occasional heavy rain the ash caused many blockages in the local stormwater system, causing localised flooding on several occasions (figure 6.1).

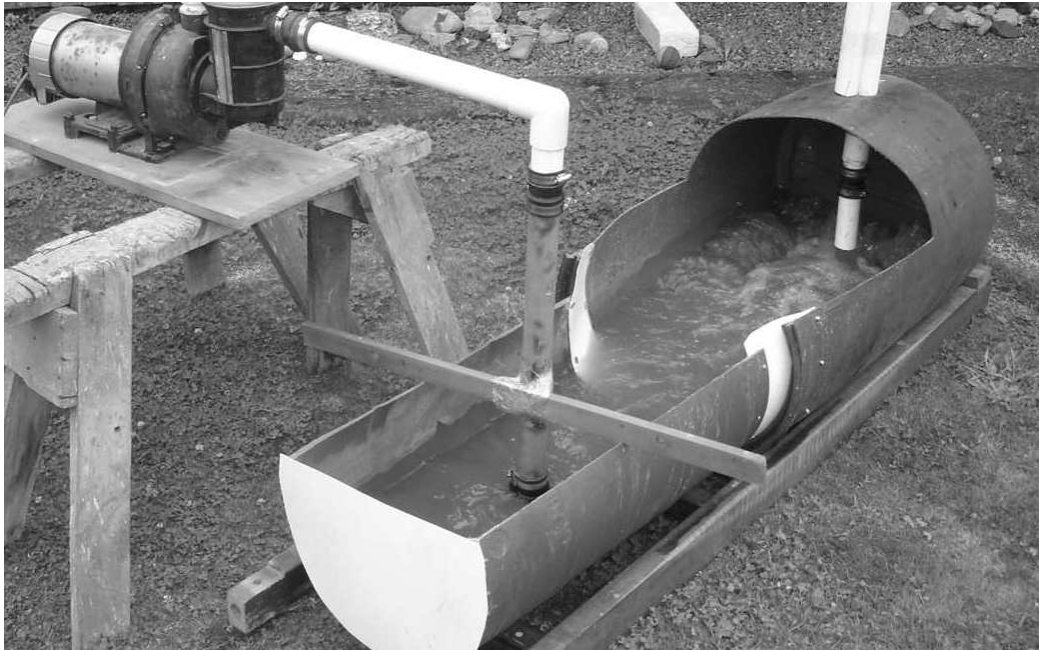
*Figure 6.3: preliminary testing using a pool pump and hemispherical sump narrowing at the intake end*

Testing was conducted by pumping ash-leaden water through the pump, into a sump and then circulating back into the pump. The sump was designed with a hemispherical cross section, with the pump intake end narrower than the opposite end. Between the

wider and narrower ends was a lip as the wide part of the sump narrowed (figure 6.3). This mirrored the shape of the sump in pump station 16 (PS16) Orakei, Auckland.

Water was pumped through the system to begin the test procedure, and ash was gradually added in 1% by volume (total fluid) increments, with any changes noted. The first test run used a coarse unsieved mix of crushed basalt. Much ash immediately settled out of suspension, despite the highly turbulent water. As expected the turbidity of the water immediately increased dramatically, the pump began to work harder. As more ash was added the turbulence of the water decreased and the turbidity increased. By the time 5% of ash had been added to the water the pump was still performing, but much ash had settled on the floor of the sump. Sedimentation was especially prevalent where the sump narrowed

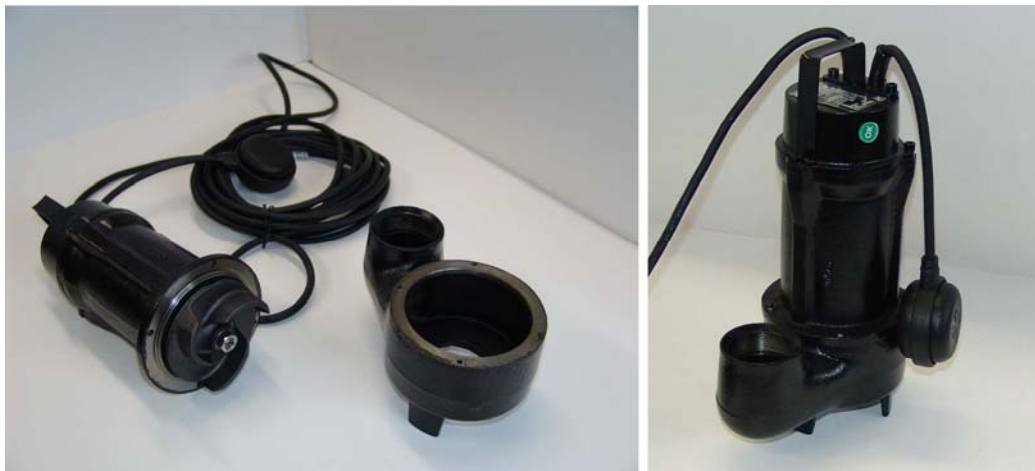
Figure 6.4: Zenit DGE 50/2/G50V effluent pump pre-testing. With base removed (left) and fully assembled (right).

Effluent pump testing was conducted on a *Zenit Draga* submersible waste pump, with a vortex set-back impeller (figure 6.4). These pumps are normally used in a variety of functions. According to the manufacturer these pumps are suitable for: “civil or industrial water treatment plants, for use in hospitals, agriculture, sanitary facilities, mining, irrigation, marble and stone work, lifting and transfer in industrial and civil installations, treatment of low and medium density industrial sludges, and for installation in public facilities, hotels, sports facilities, and campgrounds” (Zenit, 2009). The model used was a *DGE 50/2/G50V AOBM-E*. This pump is used in New Zealand for similar applications to those listed above, especially as an agricultural effluent pump. The pump is fully submersible, with a maximum head of 6 metres. The casing and impeller are constructed from EN-GJL-250 cast iron. The recessed impeller allows for the free passage of solid bodies up to 35 mm.
